**Flood Control Project Maintenance
Levee Inspections**

Fall 2012 Levee Maintenance Deficiency Summary Report

San Joaquin River Basin

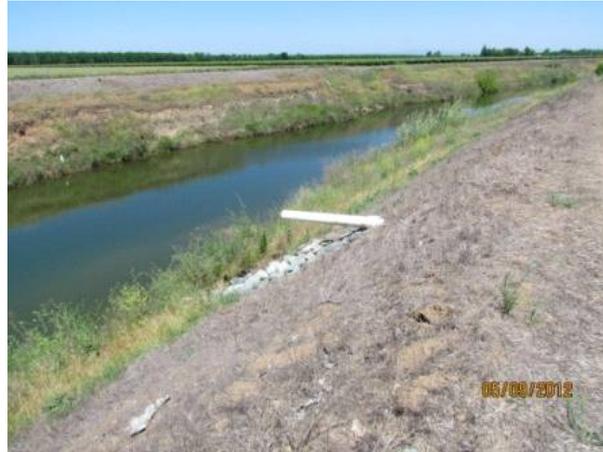
Levee Mile Report Line	112
Start Levee Mile	9.50
End Levee Mile	9.50
Location	Water Side
Category	Earthen Levee
Item	Encroachments
A PVC pipe was found on the waterside slope of the levee looking upstream.	
pkazi_f_20120913_512.jpg

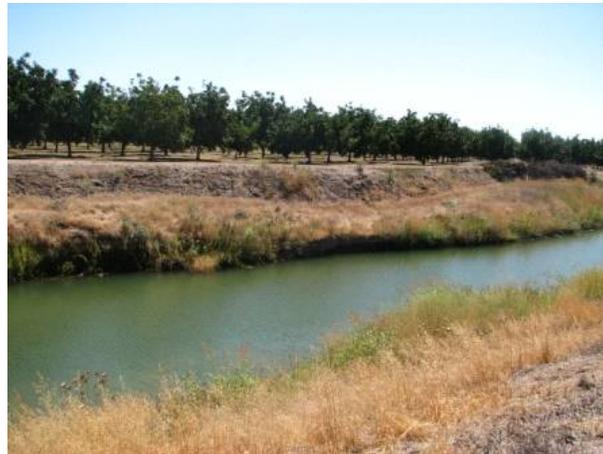
Levee Mile Report Line	113
Start Levee Mile	9.58
End Levee Mile	9.60
Location	Water Side
Category	Supplemental
Item	DWR Erosion Survey
Looking downstream at the erosion	
SJR2012_NA0017U16RM13.53_1.jpg

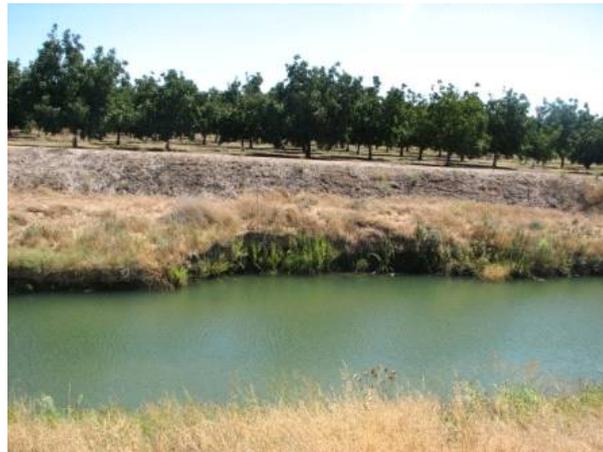
Levee Mile Report Line	113
Start Levee Mile	9.58
End Levee Mile	9.60
Location	Water Side
Category	Supplemental
Item	DWR Erosion Survey
front view of erosion	
SJR2012_NA0017U16RM13.53_2.jpg

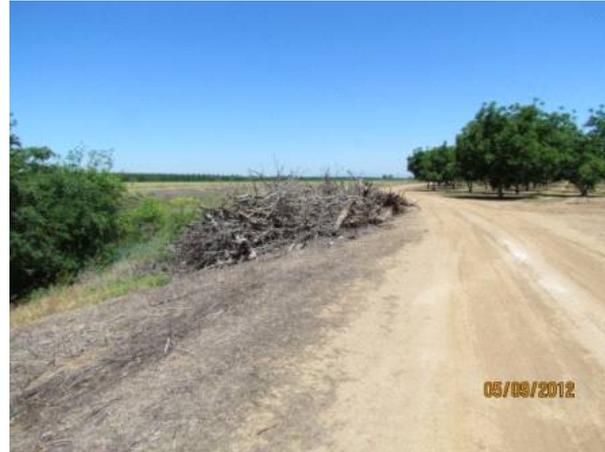
Levee Mile Report Line	114
Start Levee Mile	9.64
End Levee Mile	9.64
Location	Water Side
Category	Earthen Levee
Item	Encroachments
Prunings were found on the waterside of the levee looking upstream.	
pkazi_f_20120913_457.jpg

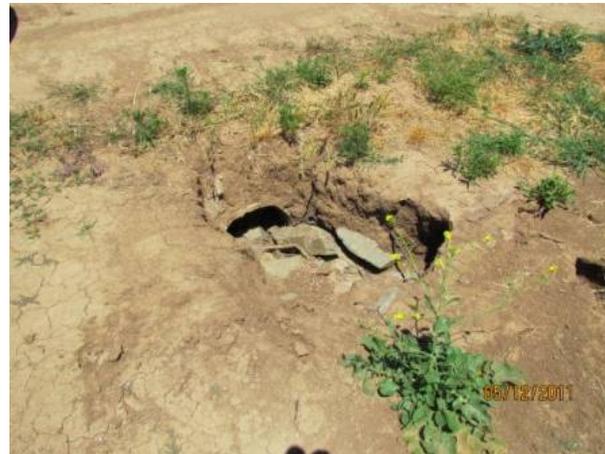
Levee Mile Report Line	115
Start Levee Mile	9.77
End Levee Mile	9.77
Location	Land Side
Category	Earthen Levee
Item	Encroachments
An abandon pipe was left by the farmer. The picture was taken from the toe of the landside of the levee looking upstream.	
pkazi_f_20120913_543.jpg

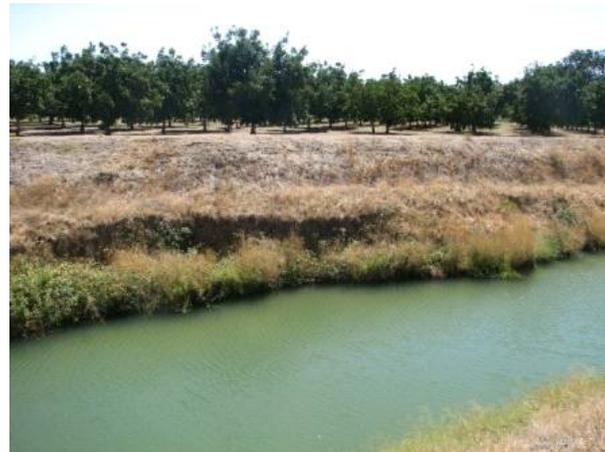
Levee Mile Report Line	116
Start Levee Mile	10.16
End Levee Mile	10.18
Location	Water Side
Category	Supplemental
Item	DWR Erosion Survey
Front view of erosion	
SJR2012_NA0017U16RM12.95_1.jpg

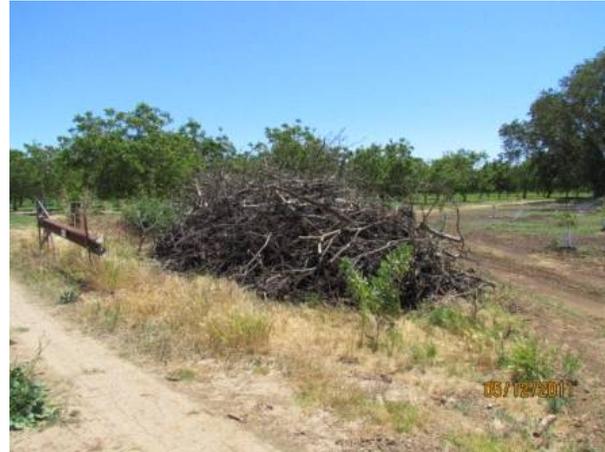
Levee Mile Report Line	117
Start Levee Mile	10.26
End Levee Mile	10.26
Location	Land Side
Category	Earthen Levee
Item	Encroachments
Prunings were found landside of the levee. The picture was taken from the crown looking upstream.	
pkazi_f_20120913_530.jpg

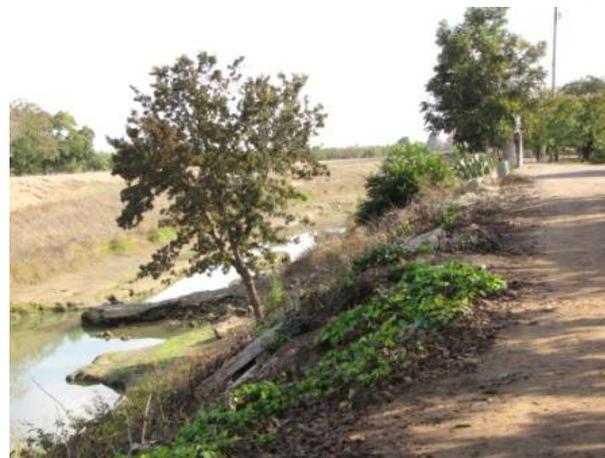
Levee Mile Report Line	121
Start Levee Mile	10.84
End Levee Mile	10.88
Location	Water Side
Category	Earthen Levee
Item	Vegetation
View of landscaping on waterward side looking upstream.	
pkazi_f_20120913_522.jpg

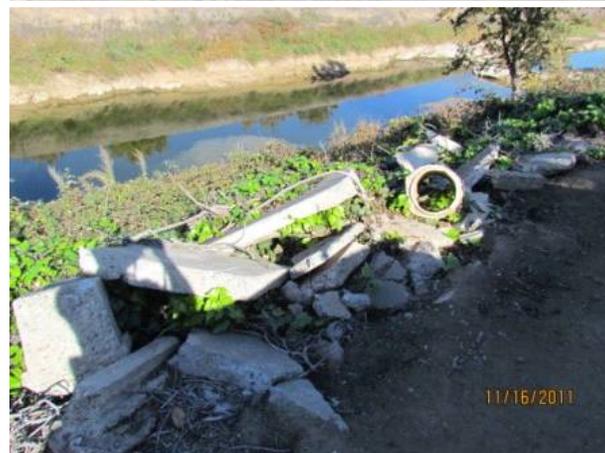
Levee Mile Report Line	122
Start Levee Mile	10.87
End Levee Mile	10.87
Location	Water Side
Category	Earthen Levee
Item	Encroachments
Concrete debris was found on the waterside of the levee looking upstream.	
pkazi_f_20120913_582.jpg

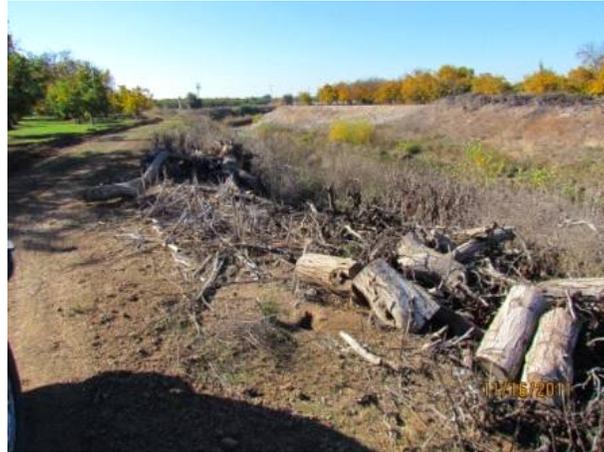
Levee Mile Report Line	123
Start Levee Mile	11.07
End Levee Mile	11.07
Location	Water Side
Category	Earthen Levee
Item	Encroachments
Prunings were found on the waterside of the levee looking downstream.	
pkazi_f_20120913_471.jpg

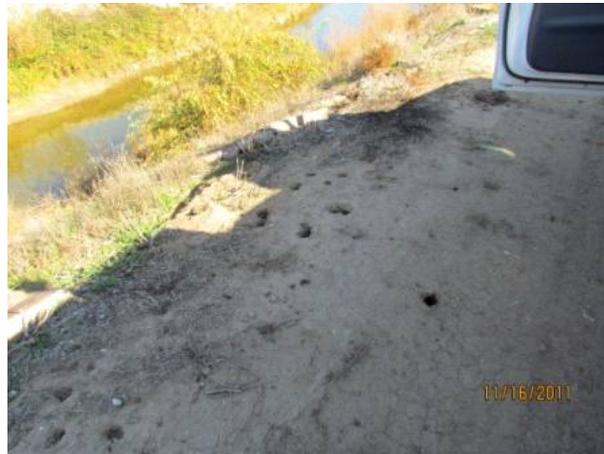
Levee Mile Report Line	124
Start Levee Mile	11.19
End Levee Mile	11.19
Location	Water Side
Category	Earthen Levee
Item	Animal Control
Rodent holes were found on the waterside of the levee looking upstream.	
pkazi_f_20120913_467.jpg

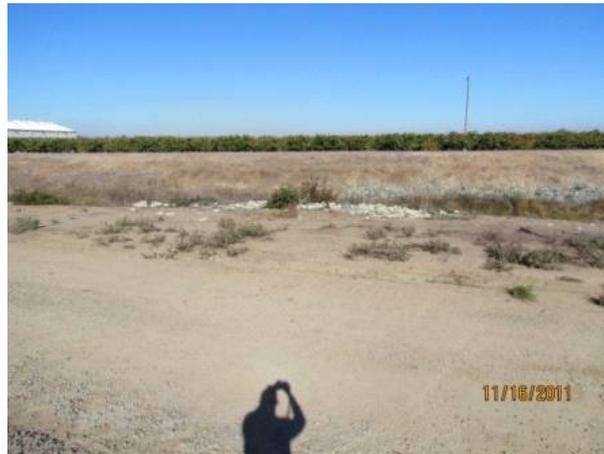
Levee Mile Report Line	125
Start Levee Mile	11.51
End Levee Mile	11.51
Location	Water Side
Category	Earthen Levee
Item	Encroachments
Concrete debris was found on the waterside of the levee looking downstream.	
pkazi_f_20120913_519.jpg

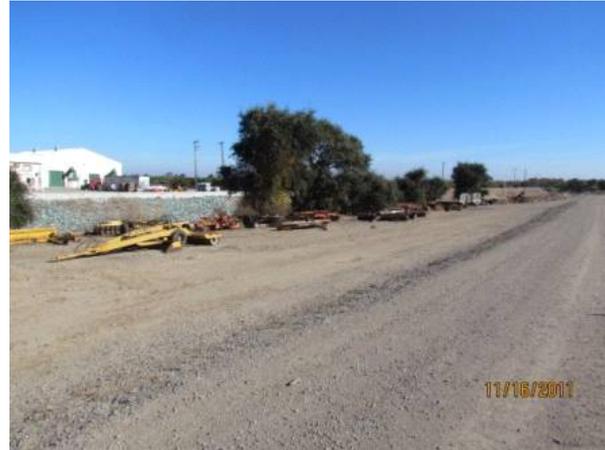
Levee Mile Report Line	126
Start Levee Mile	11.52
End Levee Mile	11.59
Location	Water Side
Category	Earthen Levee
Item	Encroachments
Equipment was found on the waterside of the levee looking upstream.	
pkazi_f_20120913_470.jpg

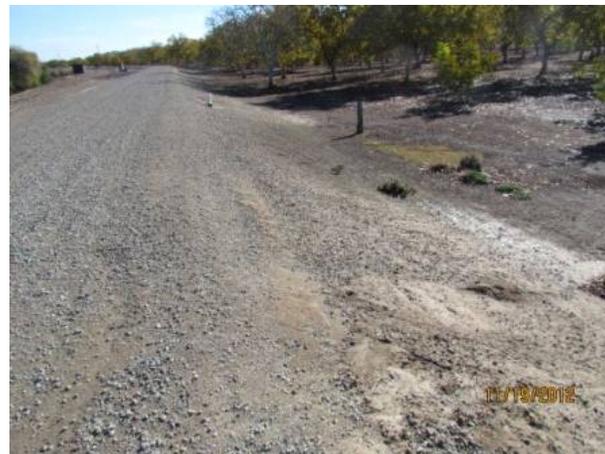
Levee Mile Report Line	128
Start Levee Mile	11.85
End Levee Mile	11.85
Location	Land Side
Category	Earthen Levee
Item	Animal Control
Animal holes were repaired by the LMA on the landside slope of the levee looking upstream.	
pkazi_f_20121121_131.jpg

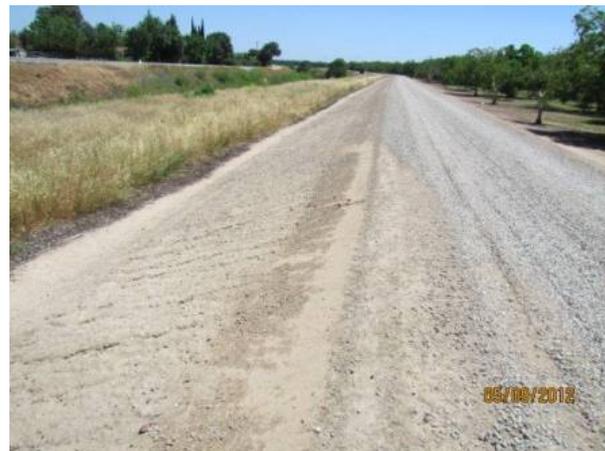
Levee Mile Report Line	131
Start Levee Mile	11.94
End Levee Mile	11.94
Location	Water Side
Category	Earthen Levee
Item	Slope Stability
Slope instability was repaired by the LMA on the waterside of the levee looking upstream.	
pkazi_f_20120913_508.jpg

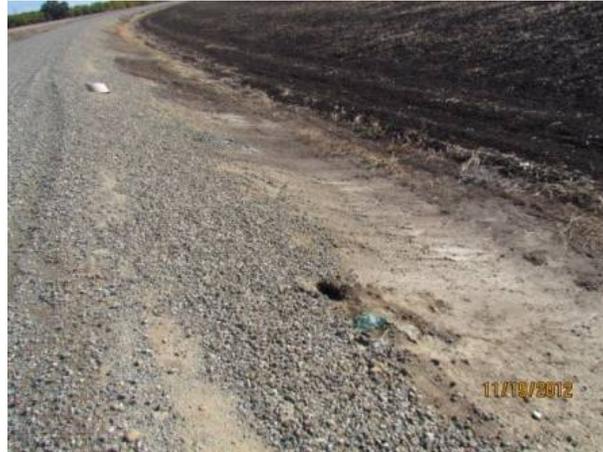
Levee Mile Report Line	134
Start Levee Mile	12.51
End Levee Mile	12.51
Location	Land Side
Category	Earthen Levee
Item	Animal Control
<p>An animal hole was found on the landside slope of the levee looking upstream.</p>	
<p>pkazi_f_20121121_130.jpg</p>

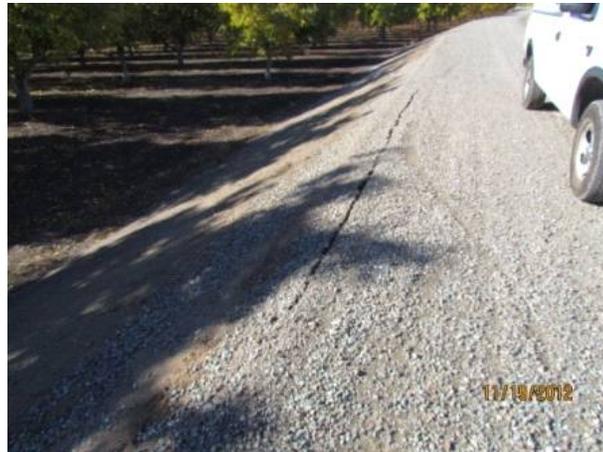
Levee Mile Report Line	137
Start Levee Mile	12.72
End Levee Mile	12.72
Location	Land Side
Category	Earthen Levee
Item	Cracking
<p>A crack was found on the landside shoulder of the levee looking downstream.</p>	
<p>pkazi_f_20121121_129.jpg</p>

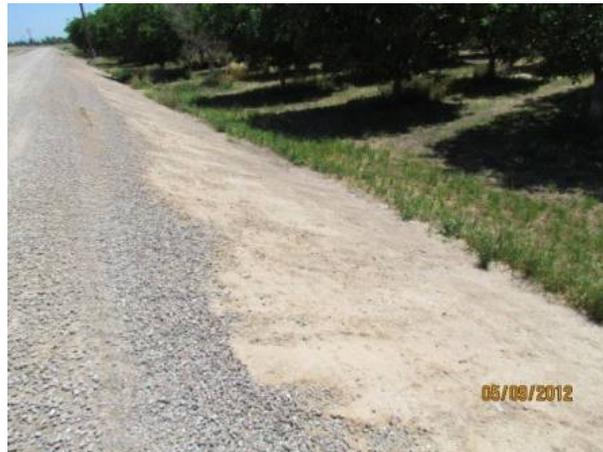
Levee Mile Report Line	138
Start Levee Mile	12.72
End Levee Mile	12.72
Location	Land Side
Category	Earthen Levee
Item	Animal Control
<p>Animal holes were fixed repaired by the LMA on the landside of the levee looking upstream.</p>	
<p>pkazi_f_20120913_498.jpg</p>

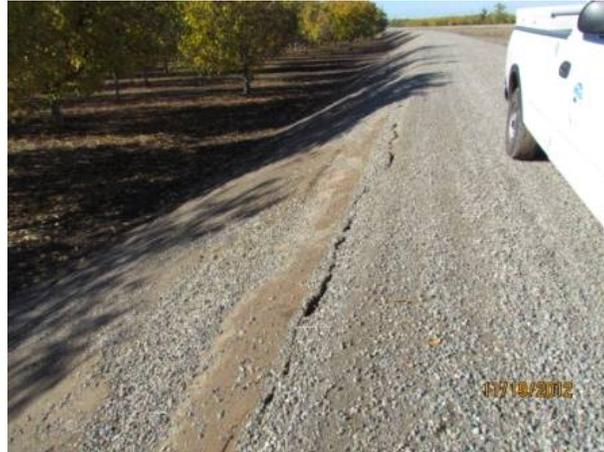
Levee Mile Report Line	139
Start Levee Mile	12.81
End Levee Mile	12.81
Location	Land Side
Category	Earthen Levee
Item	Cracking
<p>A crack was found on the landside shoulder of the levee looking downstream.</p>	
<p>pkazi_f_20121121_128.jpg</p>

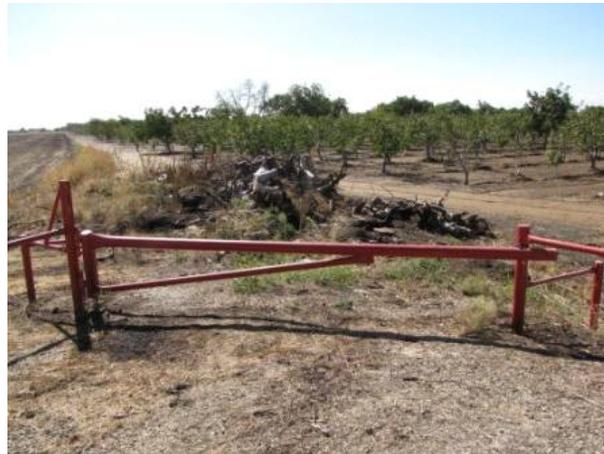
Levee Mile Report Line	140
Start Levee Mile	13.17
End Levee Mile	13.17
Location	Land Side
Category	Earthen Levee
Item	Encroachments
<p>View of a prunings pile along the landward toe of an access ramp. Pile is blocking access through this gate.</p>	
<p>pkazi_f_20120913_513.jpg</p>

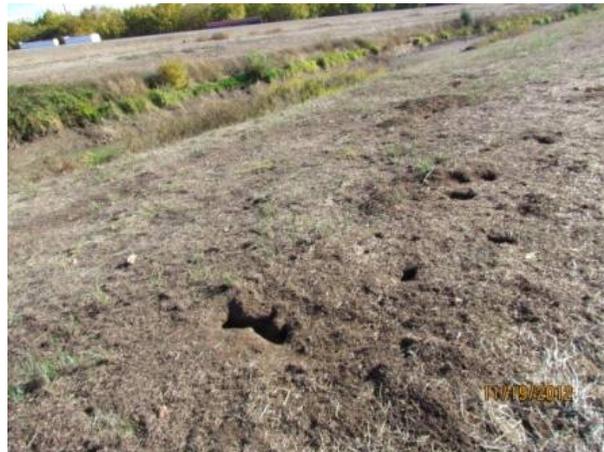
Levee Mile Report Line	141
Start Levee Mile	13.30
End Levee Mile	13.30
Location	Water Side
Category	Earthen Levee
Item	Animal Control
<p>Animal holes were found on the waterside slope of the levee looking upstream.</p>	
<p>pkazi_f_20121121_127.jpg</p>

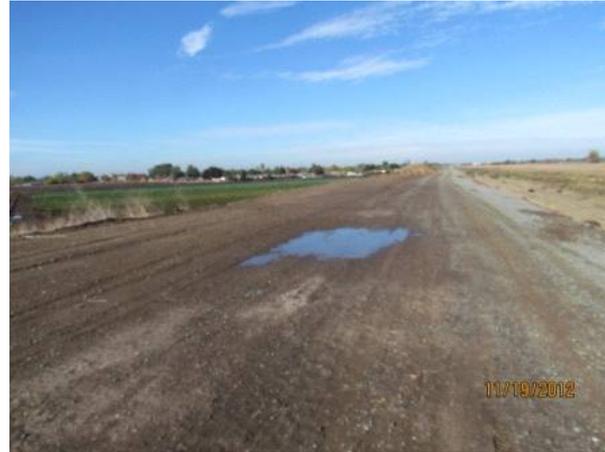
Levee Mile Report Line	142
Start Levee Mile	14.07
End Levee Mile	14.07
Location	Crown
Category	Earthen Levee
Item	Crown Surface / Depressions / Rutting
Depression was located at the crown of the levee looking downstream.	
pkazi_f_20121121_126.jpg

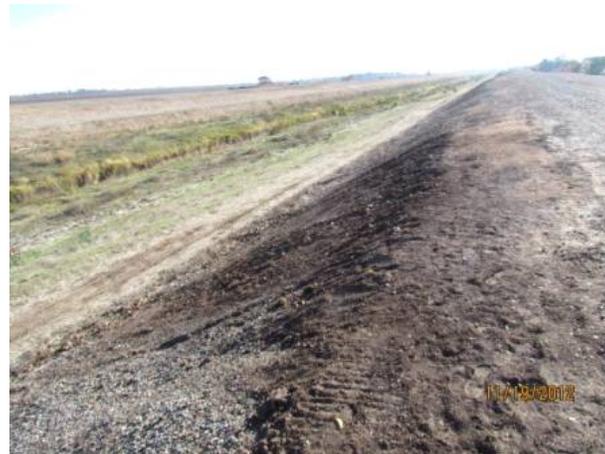
Levee Mile Report Line	144
Start Levee Mile	14.85
End Levee Mile	14.85
Location	Water Side
Category	Earthen Levee
Item	Slope Stability
Slope instability was repaired by the LMA on the waterside slope of the levee looking upstream.	
pkazi_f_20121121_125.jpg

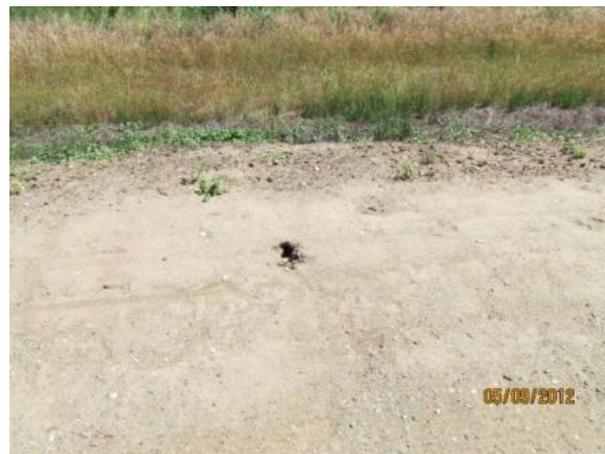
Levee Mile Report Line	148
Start Levee Mile	15.35
End Levee Mile	15.35
Location	Water Side
Category	Earthen Levee
Item	Animal Control
An animal hole was found on the waterside of the levee looking upstream.	
pkazi_f_20120913_496.jpg

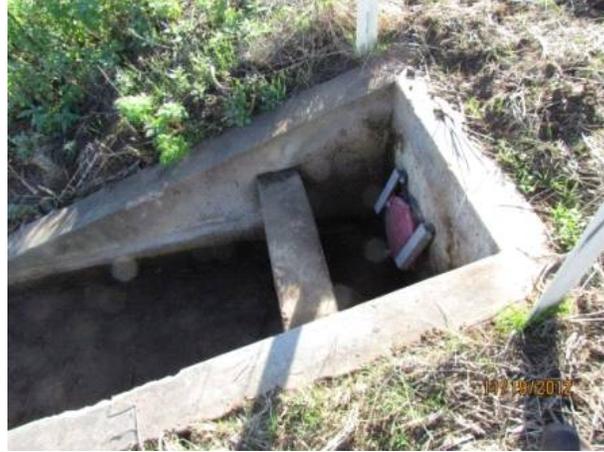
pkazi_f_20121121_124.jpg

The LMA placed a flap gate and cleaned the outlet on the waterside toe of the levee looking upstream.

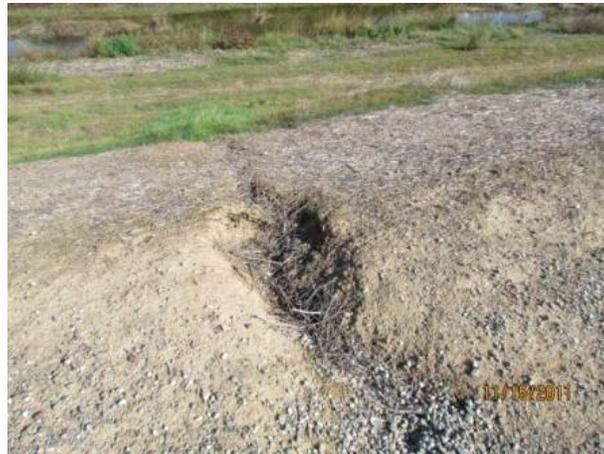
pkazi_f_20120913_571.jpg

Levee Mile Report Line	151
Start Levee Mile	15.91
End Levee Mile	15.91
Location	Water Side
Category	Earthen Levee
Item	Slope Stability

Slope instability was found on the waterside of the levee looking upstream.

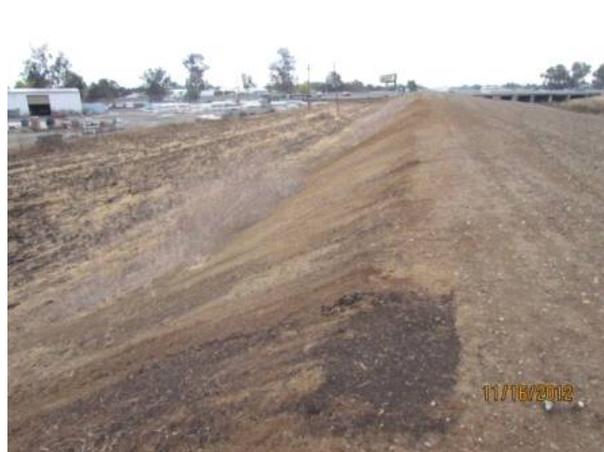
pkazi_f_20121120_122.jpg

Levee Mile Report Line	157
Start Levee Mile	16.54
End Levee Mile	16.54
Location	Land Side
Category	Earthen Levee
Item	Slope Stability

Slope instability was repaired by the LMA on the landside slope of the levee looking downstream.

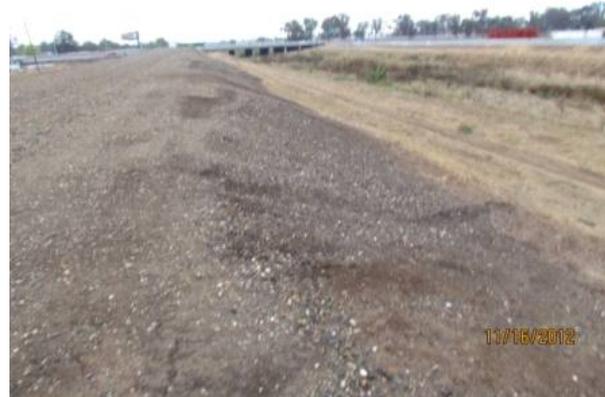
Levee Mile Report Line	158
Start Levee Mile	16.54
End Levee Mile	16.54
Location	Water Side
Category	Earthen Levee
Item	Slope Stability
Slope instability was repaired by the LMA on the waterside slope of the levee looking downstream.	
pkazi_f_20121120_121.jpg

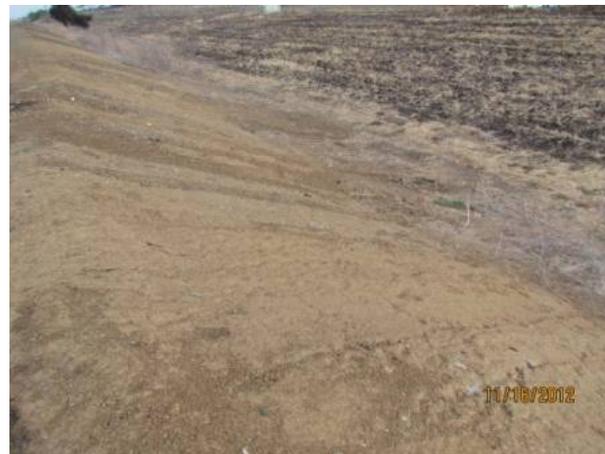
Levee Mile Report Line	160
Start Levee Mile	16.57
End Levee Mile	16.57
Location	Land Side
Category	Earthen Levee
Item	Animal Control
Animal hole was repaired by the LMA on the landside slope of the levee looking upstream.	
pkazi_f_20121120_123.jpg

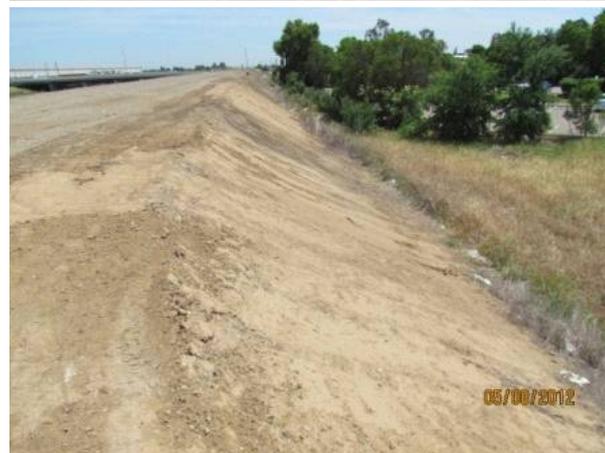
Levee Mile Report Line	161
Start Levee Mile	16.86
End Levee Mile	16.86
Location	Land Side
Category	Earthen Levee
Item	Slope Stability
Slope instability was repaired by the LMA on the landside of the levee looking upstream.	
pkazi_f_20120913_485.jpg

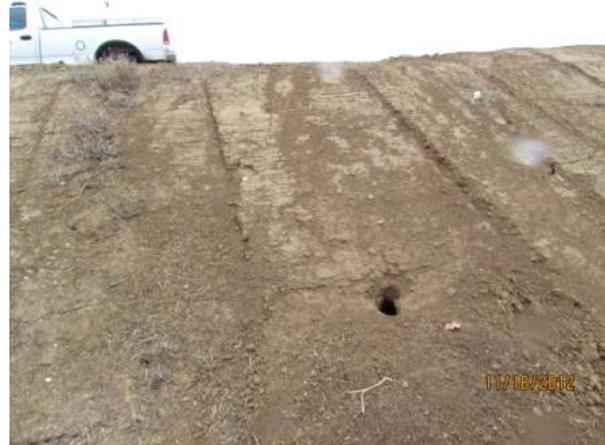
Levee Mile Report Line	163
Start Levee Mile	16.97
End Levee Mile	16.97
Location	Water Side
Category	Earthen Levee
Item	Animal Control
An animal hole was found on the landside toe looking towards the crown of the levee.	
pkazi_f_20121120_120.jpg

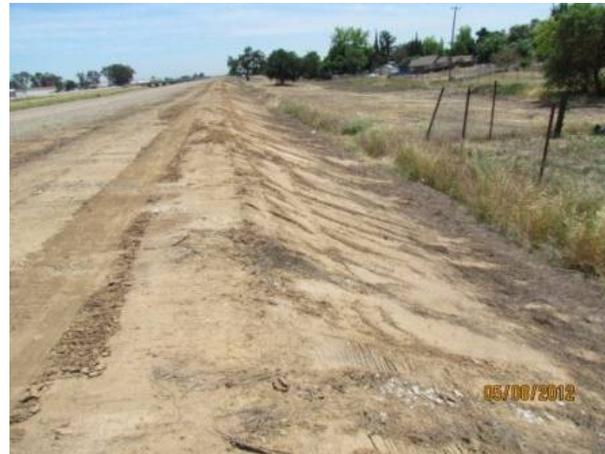
Levee Mile Report Line	164
Start Levee Mile	17.19
End Levee Mile	17.19
Location	Land Side
Category	Earthen Levee
Item	Slope Stability
Slope instability was repaired by the LMA on the landside of the levee looking upstream.	
pkazi_f_20120913_480.jpg

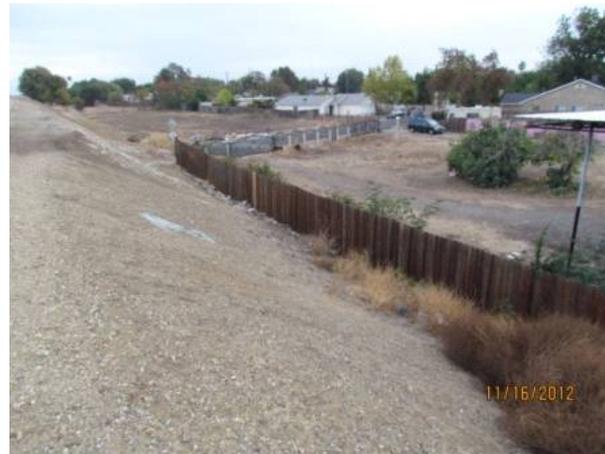
Levee Mile Report Line	166
Start Levee Mile	17.57
End Levee Mile	17.61
Location	Land Side
Category	Earthen Levee
Item	Encroachments
Fence was found on the landside toe of the levee looking upstream.	
pkazi_f_20121120_119.jpg

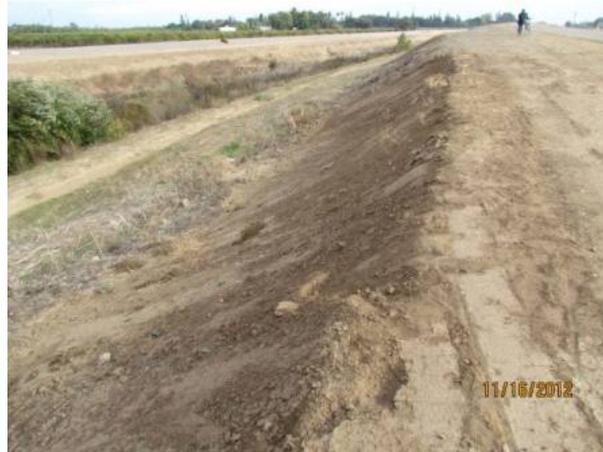
Levee Mile Report Line	168
Start Levee Mile	18.55
End Levee Mile	18.55
Location	Water Side
Category	Earthen Levee
Item	Slope Stability
Erosion was fixed by the LMA on the waterside slope of the levee looking upstream.	
pkazi_f_20121120_118.jpg

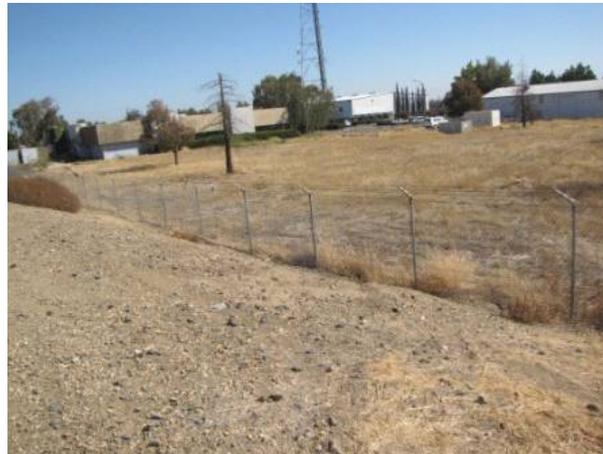
Levee Mile Report Line	171
Start Levee Mile	19.00
End Levee Mile	19.20
Location	Land Side
Category	Earthen Levee
Item	Encroachments
View of a fence along the landward toe looking upstream.	
pkazi_f_20120913_509.jpg

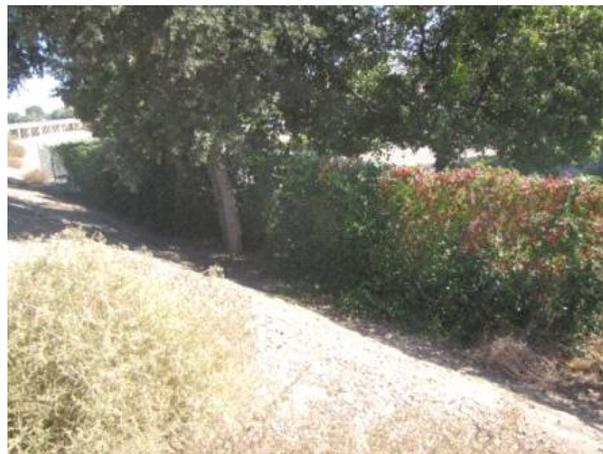
Levee Mile Report Line	172
Start Levee Mile	19.12
End Levee Mile	19.14
Location	Land Side
Category	Earthen Levee
Item	Vegetation
View of landscaping along the landward toe.	
pkazi_f_20120913_510.jpg

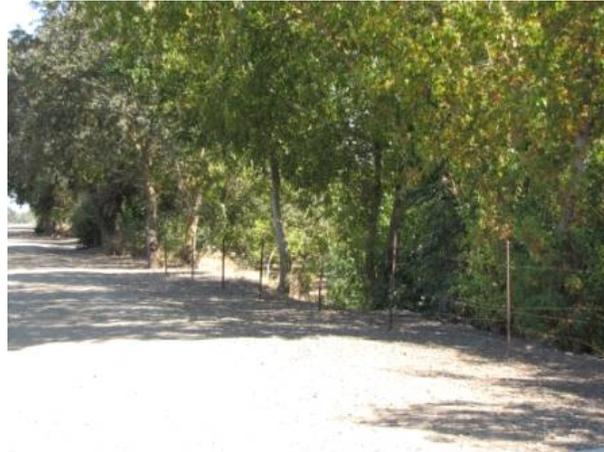
Levee Mile Report Line	173
Start Levee Mile	19.47
End Levee Mile	19.60
Location	Land Side
Category	Earthen Levee
Item	Encroachments
View of a barbed wire fence and landscaping along the landward shoulder and slope looking upstream.	
pkazi_f_20120913_503.jpg

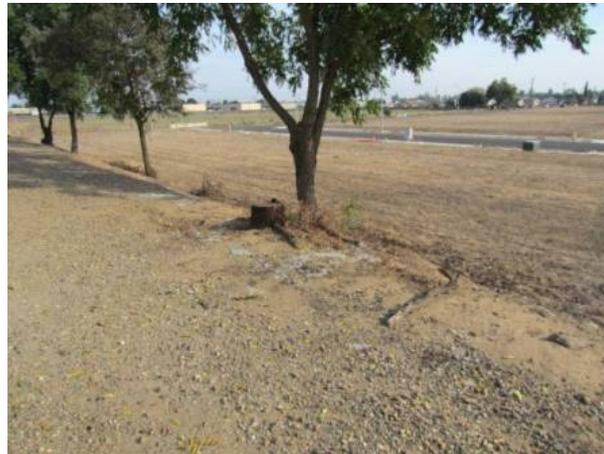
Levee Mile Report Line	174
Start Levee Mile	19.48
End Levee Mile	19.48
Location	Land Side
Category	Earthen Levee
Item	Trim / Thin Trees
Tree stump was found on the landside of the levee looking upstream.	
pkazi_f_20120913_458.jpg

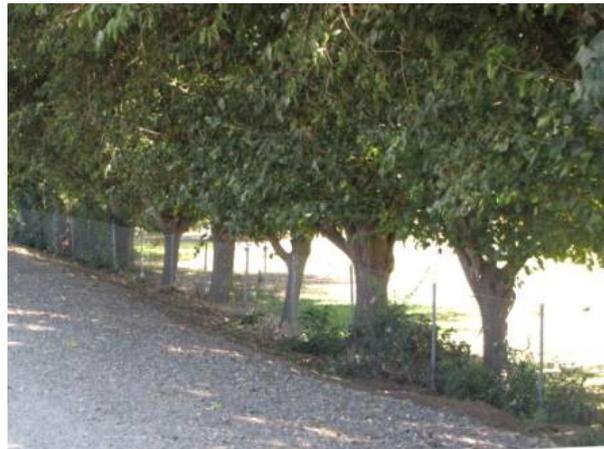
Levee Mile Report Line	176
Start Levee Mile	19.60
End Levee Mile	19.69
Location	Land Side
Category	Earthen Levee
Item	Encroachments
View of a fence along the landward slope looking upstream.	
pkazi_f_20120913_502.jpg

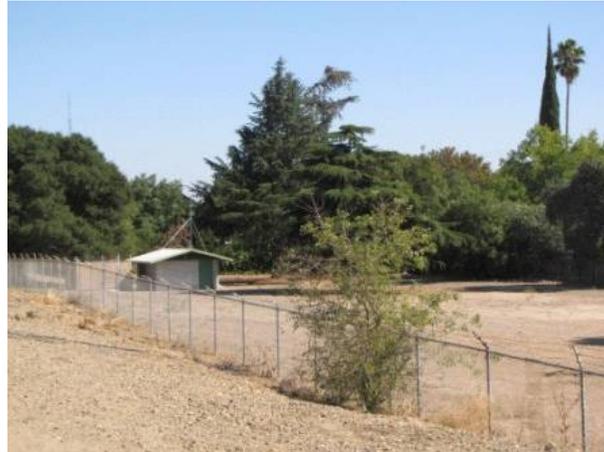
pkazi_f_20120913_501.jpg

View of a fence along the landward toe looking upstream.

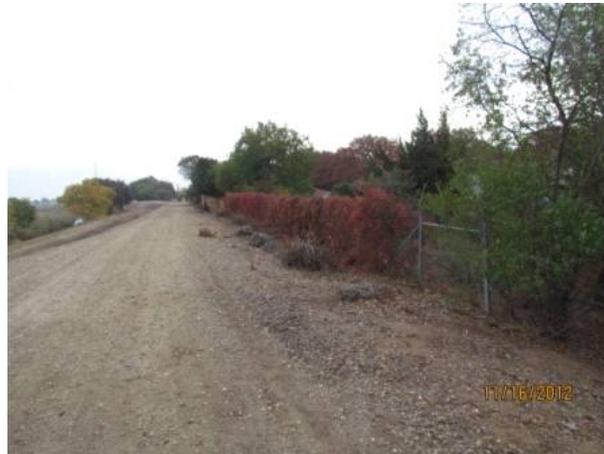
pkazi_f_20121120_117.jpg

Levee Mile Report Line	178
Start Levee Mile	19.83
End Levee Mile	19.83
Location	Land Side
Category	Earthen Levee
Item	Vegetation

Landscaping were found on the landside shoulder of the levee looking upstream.

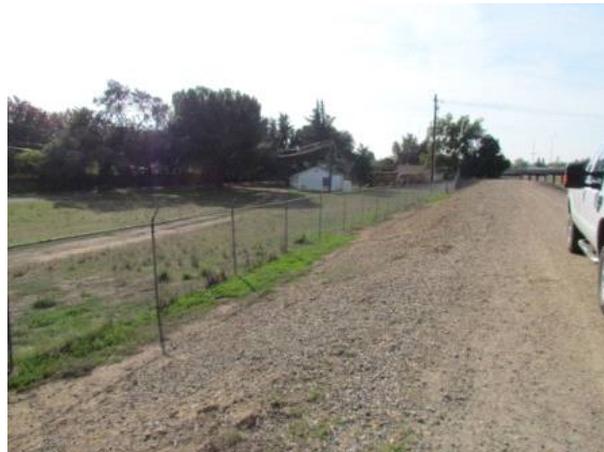
pkazi_f_20120913_500.jpg

Levee Mile Report Line	179
Start Levee Mile	19.90
End Levee Mile	19.91
Location	Land Side
Category	Earthen Levee
Item	Encroachments

Wire fence was found on the toe of landside of the levee looking downstream.

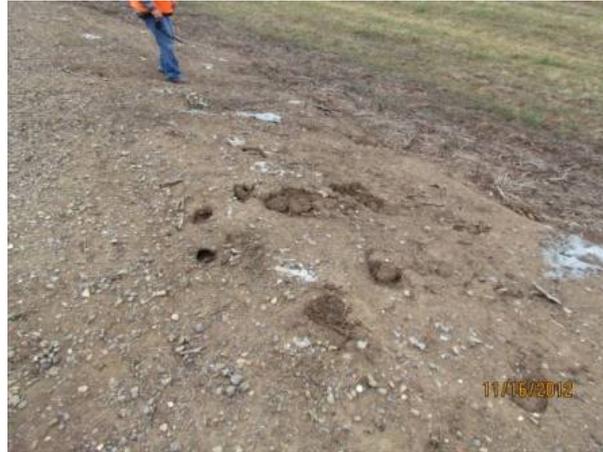
Levee Mile Report Line	181
Start Levee Mile	20.05
End Levee Mile	20.05
Location	Water Side
Category	Earthen Levee
Item	Animal Control
Animal holes were found on the landside slope of the levee looking downstream.	
pkazi_f_20121120_116.jpg

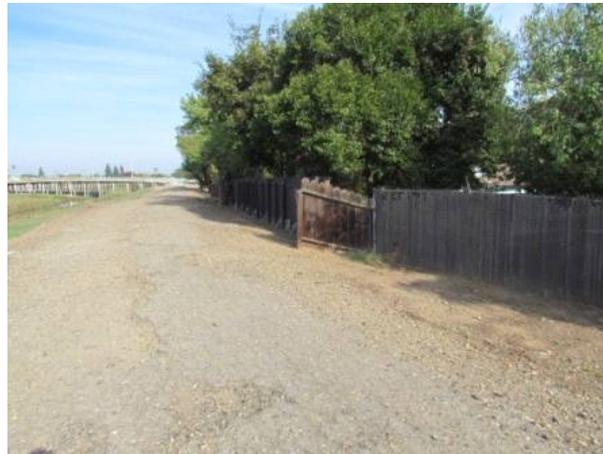
Levee Mile Report Line	182
Start Levee Mile	20.05
End Levee Mile	20.05
Location	Land Side
Category	Earthen Levee
Item	Encroachments
Wooden fence on the landside of the levee looking upstream.	
pkazi_f_20120913_446.jpg

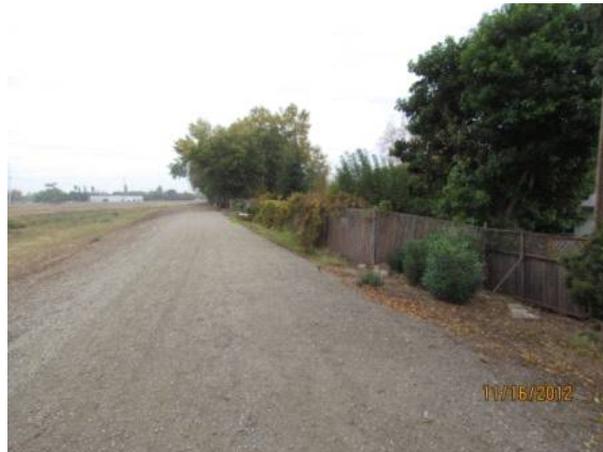
Levee Mile Report Line	191
Start Levee Mile	20.23
End Levee Mile	20.23
Location	Land Side
Category	Earthen Levee
Item	Encroachments
A fence was found on the landside shoulder of the levee looking upstream.	
pkazi_f_20121120_115.jpg

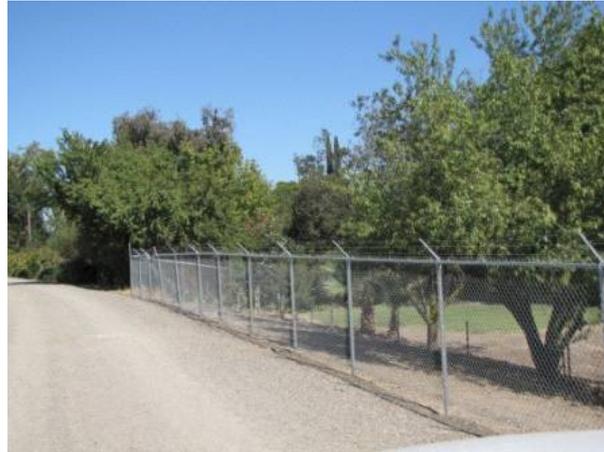
pkazi_f_20120913_499.jpg

View of a fence along the landward slope looking upstream.

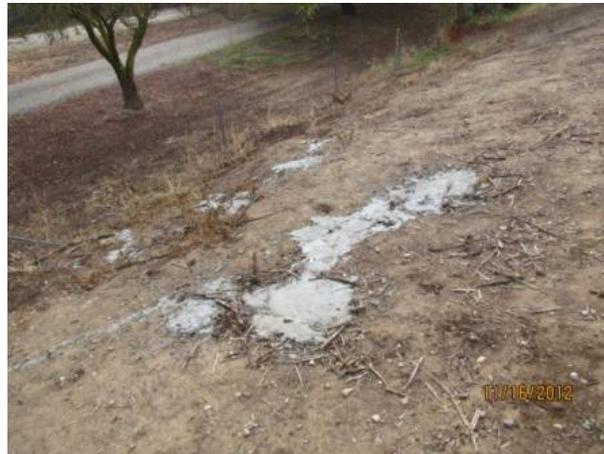
pkazi_f_20121120_114.jpg

Levee Mile Report Line	195
Start Levee Mile	20.39
End Levee Mile	20.39
Location	Land Side
Category	Earthen Levee
Item	Animal Control

Animal holes were grouted on the landside slope of the levee looking downstream.

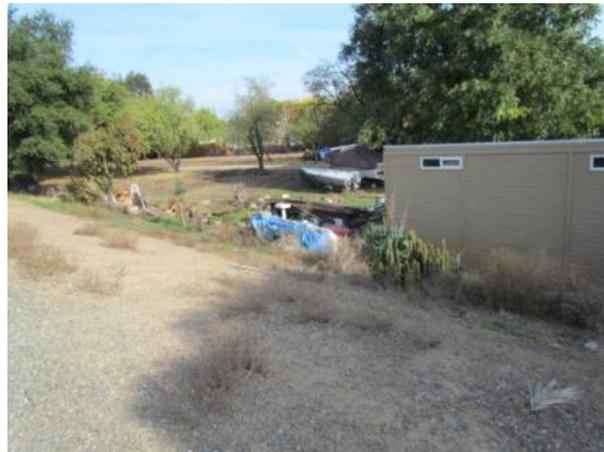
pkazi_f_20120913_539.jpg

Levee Mile Report Line	196
Start Levee Mile	20.45
End Levee Mile	20.48
Location	Land Side
Category	Earthen Levee
Item	Vegetation

Landscaping was found on the toe of landside of the levee looking upstream.

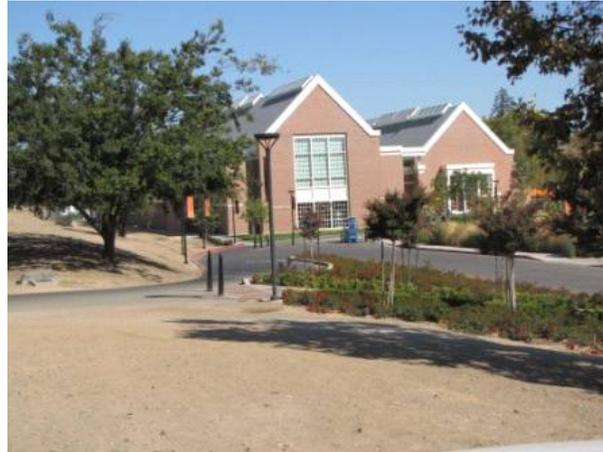
Levee Mile Report Line	197
Start Levee Mile	20.83
End Levee Mile	20.83
Location	Land Side
Category	Earthen Levee
Item	Vegetation
View of landscaping planted and maintained by UOP along the landward slope and toe looking upstream.	
pkazi_f_20120913_497.jpg

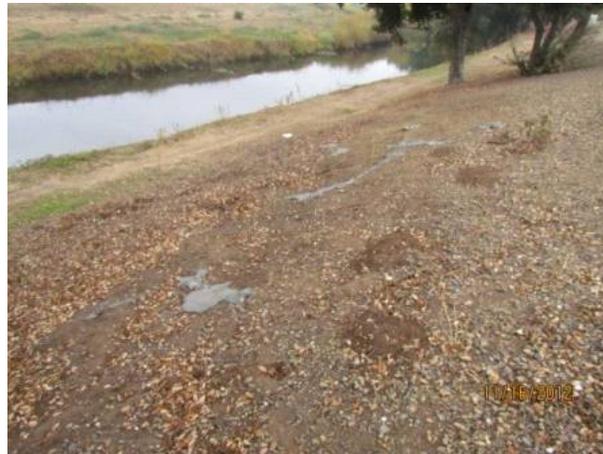
Levee Mile Report Line	198
Start Levee Mile	21.02
End Levee Mile	21.02
Location	Water Side
Category	Earthen Levee
Item	Animal Control
Animal holes were grouted by the LMA on the waterside slope of the levee looking upstream.	
pkazi_f_20121120_113.jpg

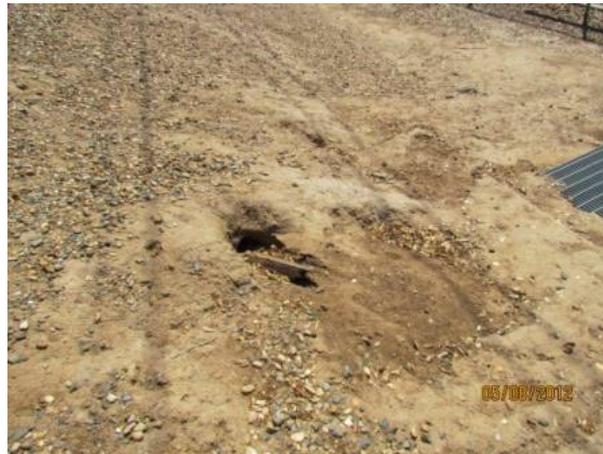
Levee Mile Report Line	200
Start Levee Mile	21.02
End Levee Mile	21.02
Location	Land Side
Category	Earthen Levee
Item	Animal Control
An animal hole was found on the landside of the levee looking upstream.	
pkazi_f_20120913_475.jpg

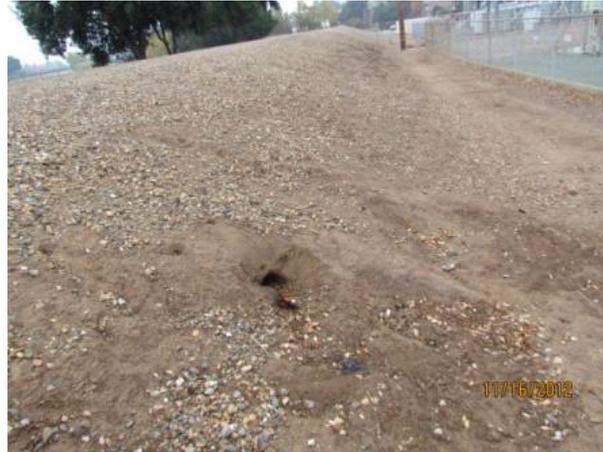
Levee Mile Report Line	200
Start Levee Mile	21.02
End Levee Mile	21.02
Location	Land Side
Category	Earthen Levee
Item	Animal Control
Updated picture of the animal hole on the landside slope of the levee looking upstream.	
pkazi_f_20121120_112.jpg

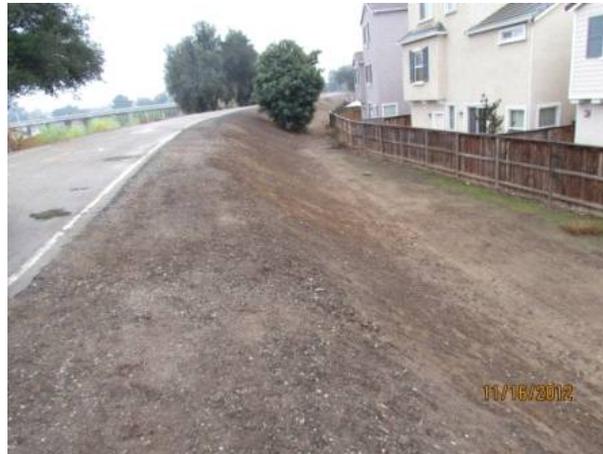
Levee Mile Report Line	207
Start Levee Mile	21.31
End Levee Mile	21.31
Location	Land Side
Category	Earthen Levee
Item	Erosion / Bank Caving
Erosion was repaired by the LMA on the landside slope of the levee looking upstream.	
pkazi_f_20121120_111.jpg

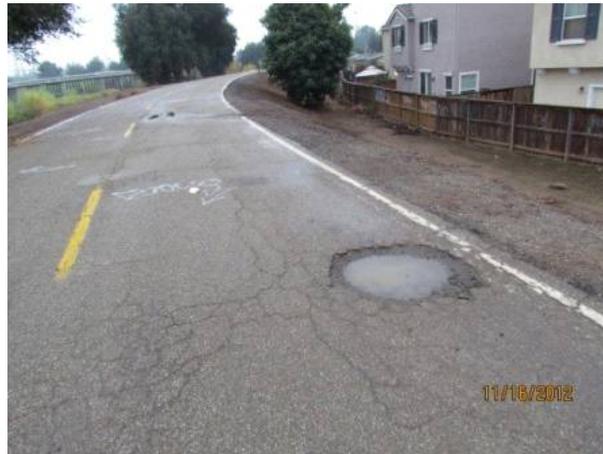
Levee Mile Report Line	208
Start Levee Mile	21.31
End Levee Mile	21.31
Location	Crown
Category	Earthen Levee
Item	Crown Surface / Depressions / Rutting
Crown depression was found on the levee access road looking upstream.	
pkazi_f_20121120_110.jpg

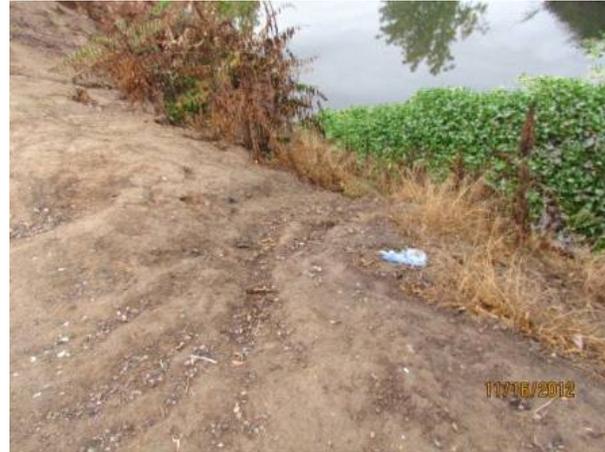
Levee Mile Report Line	209
Start Levee Mile	21.36
End Levee Mile	21.36
Location	Water Side
Category	Earthen Levee
Item	Erosion / Bank Caving
Erosion was found on the waterside shoulder of the levee looking downstream.	
pkazi_f_20121120_109.jpg

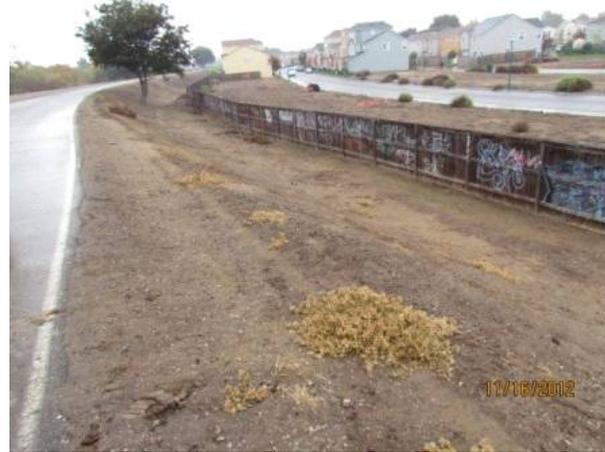
Levee Mile Report Line	210
Start Levee Mile	21.45
End Levee Mile	21.45
Location	Land Side
Category	Earthen Levee
Item	Erosion / Bank Caving
Erosion was repaired by the LMA on the landside slope of the levee looking upstream.	
pkazi_f_20121120_108.jpg

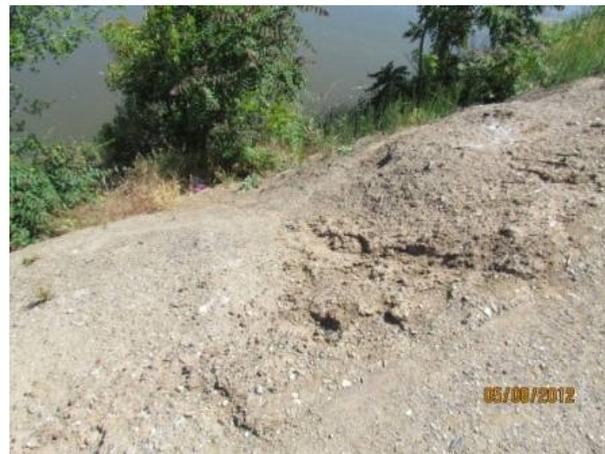
Levee Mile Report Line	211
Start Levee Mile	21.47
End Levee Mile	21.47
Location	Water Side
Category	Earthen Levee
Item	Slope Stability
Slope instability was found on the waterside of the levee looking upstream.	
pkazi_f_20120913_468.jpg

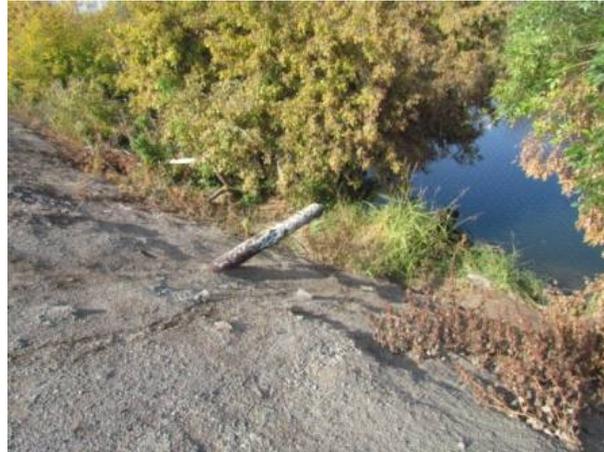
Levee Mile Report Line	213
Start Levee Mile	21.54
End Levee Mile	21.54
Location	Water Side
Category	Earthen Levee
Item	Encroachments
An abandoned pipe was found on the waterside of the levee looking downstream.	
pkazi_f_20120913_565.jpg

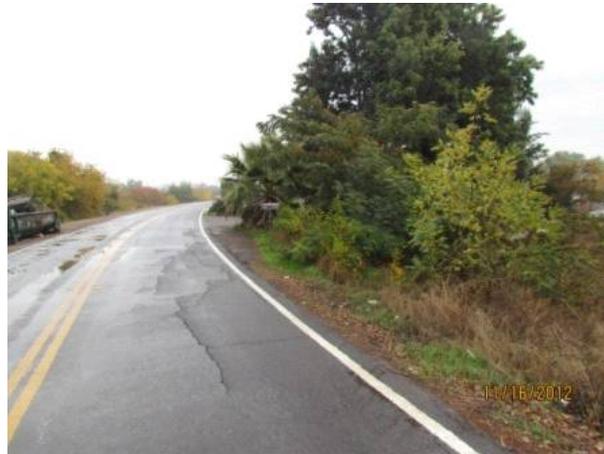
Levee Mile Report Line	217
Start Levee Mile	21.71
End Levee Mile	21.71
Location	Land Side
Category	Earthen Levee
Item	Vegetation
Landscaping was found on the landside shoulder of the levee looking upstream.	
pkazi_f_20121120_107.jpg

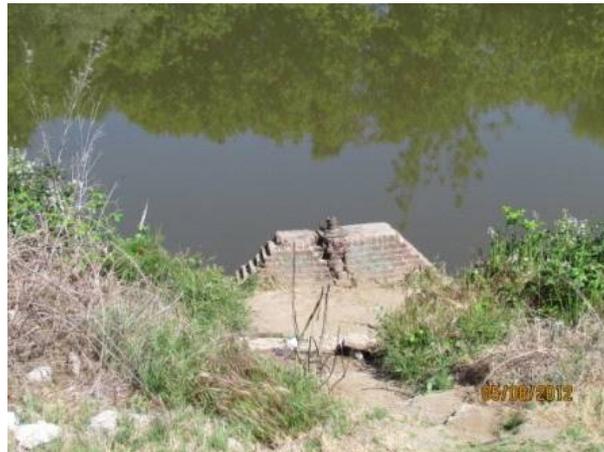
Levee Mile Report Line	219
Start Levee Mile	21.84
End Levee Mile	21.84
Location	Water Side
Category	Earthen Levee
Item	Encroachments
A retaining wall was found on the waterside toe of the levee looking upstream.	
pkazi_f_20120913_460.jpg

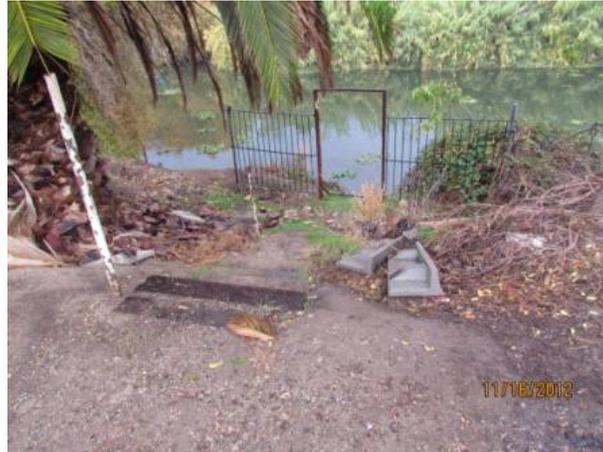
Levee Mile Report Line	224
Start Levee Mile	21.91
End Levee Mile	21.91
Location	Water Side
Category	Earthen Levee
Item	Encroachments
Stairs and fence were located on the waterside slope of the levee looking downstream.	
pkazi_f_20121120_105.jpg

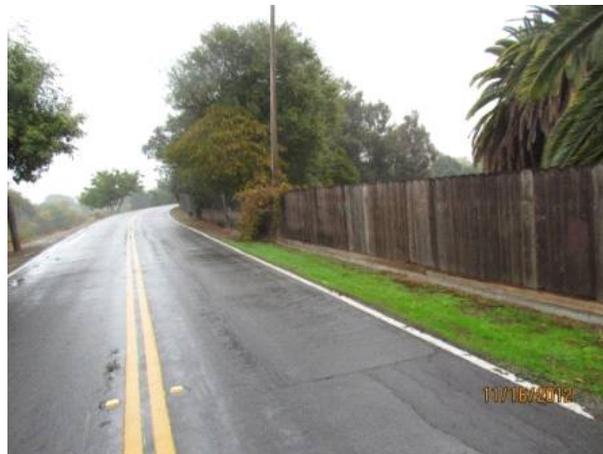
Levee Mile Report Line	225
Start Levee Mile	21.91
End Levee Mile	21.91
Location	Land Side
Category	Earthen Levee
Item	Encroachments
A fence was found on the landside shoulder of the levee looking upstream.	
pkazi_f_20121120_106.jpg

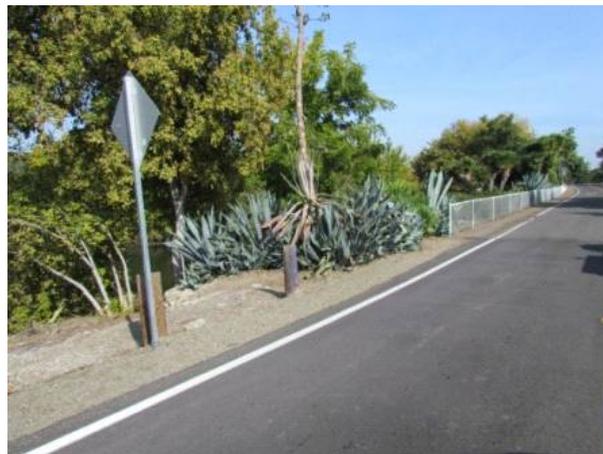
Levee Mile Report Line	226
Start Levee Mile	21.97
End Levee Mile	21.97
Location	Water Side
Category	Earthen Levee
Item	Vegetation
View of landscaping on the waterside of the levee looking upstream.	
pkazi_f_20120913_444.jpg

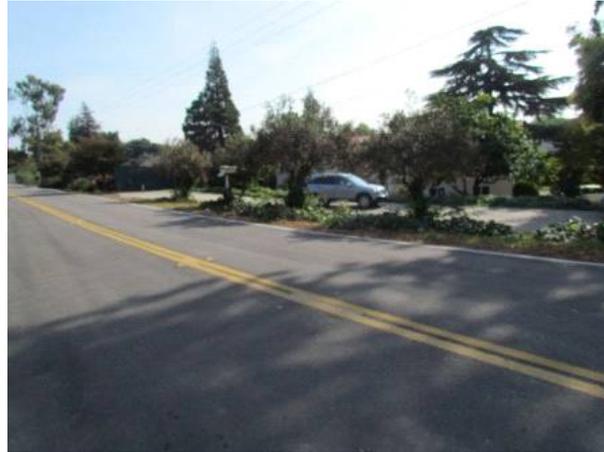
Levee Mile Report Line	228
Start Levee Mile	22.08
End Levee Mile	22.08
Location	Land Side
Category	Earthen Levee
Item	Vegetation
View of the landscape on the landside of the levee looking upstream.	
pkazi_f_20120913_443.jpg

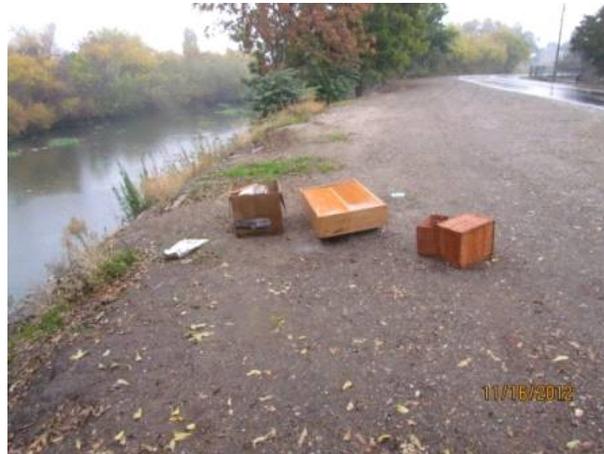
Levee Mile Report Line	231
Start Levee Mile	22.15
End Levee Mile	22.15
Location	Water Side
Category	Earthen Levee
Item	Encroachments
Debris was found on the waterside shoulder of the levee looking upstream.	
pkazi_f_20121120_104.jpg

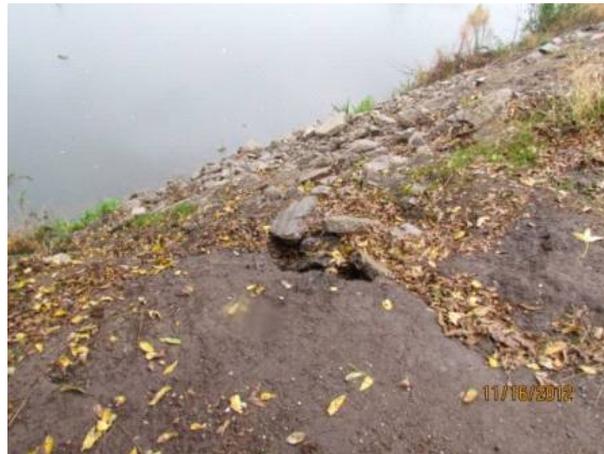
Levee Mile Report Line	232
Start Levee Mile	22.15
End Levee Mile	22.15
Location	Water Side
Category	Earthen Levee
Item	Erosion / Bank Caving
Erosion was found on the waterside slope of the levee looking upstream.	
pkazi_f_20121120_103.jpg

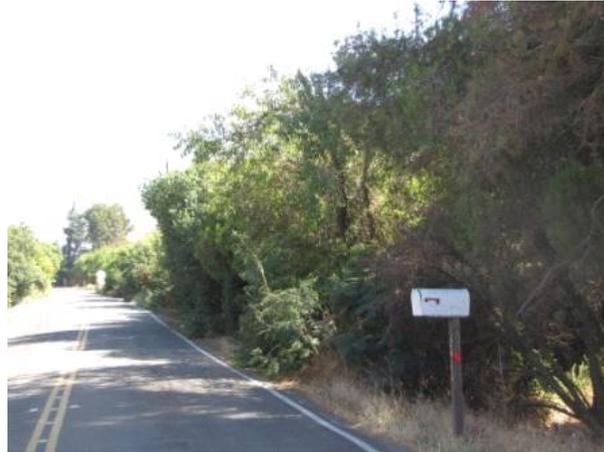
pkazi_f_20120913_491.jpg

View of landscaping along landward slope looking upstream.
